Starlite Hotel- Project Summary

Project Name: Starlite Hotel

Address: 17 D'Edward Village, Berbice

Starlite Hotel Project Summary

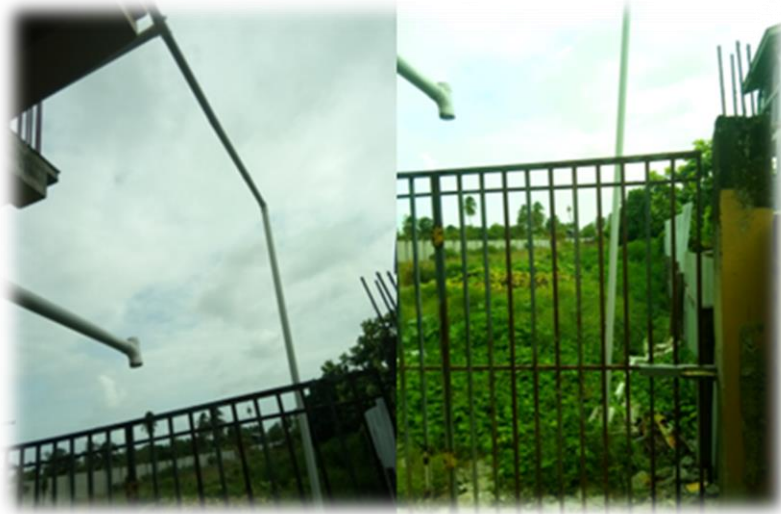
Figure 2: Pipes extending from hotel to drain in empty lot south of the hotel

There are no internal drains on site, since stormwater and gray water are captured by a series of interconnected PVC pipes (figure 2). This includes discharges from rainwater, water from kitchen pipes and the laundry rooms. The pipe extends 100 feet south, into a drain situated on the empty lot (approximately 2 feet from the fence), which was dug by the landowner.

There are no internal drains at the hotel. Stormwater is channeled along with water from the laundry room into a single pipe which exits south of the hotel via a 100ft pipe. The water is discharged into a drain dug on the land owned by the Hotel's proprietor.

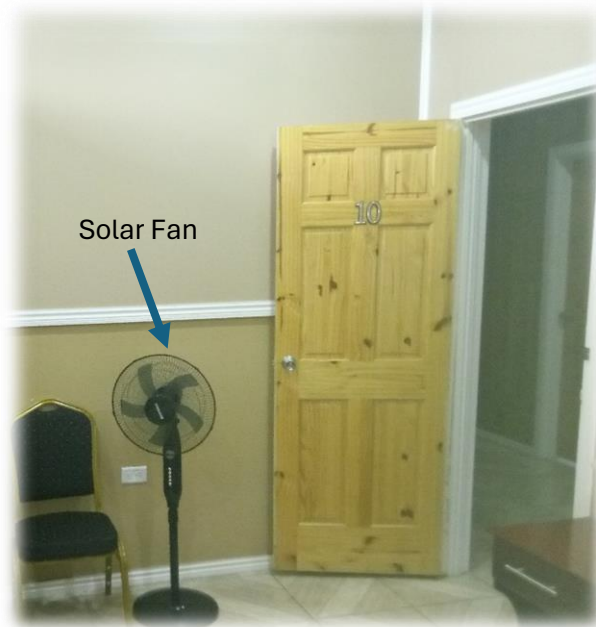
Figure 4: Solar fan in guest room

The hotel is powered strictly by the electricity provided by the Guyana Power and Light Incorporated. No generators are onsite, nor are they expected to be used as part of the Hotel's operation. Solar lights and fans provide lighting and cooling in rooms during periods of power outages (figure 4). Additionally, permanent solar lights provide illumination to the western passageway in the yard (figure 5).

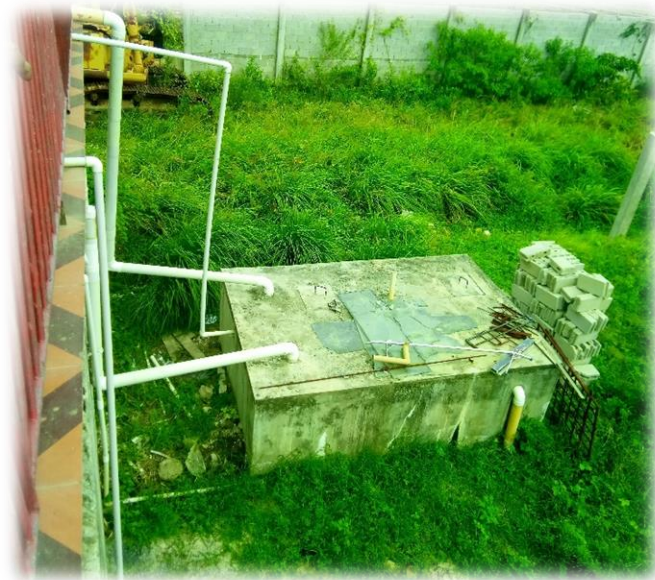
Figure 7: Septic tank situated south of the hotel

The water mitigation strategies will entail measures geared towards water conservation and will therefore include the frequent inspections of faucets as part of the daily house-keeping routine. As such, any leaks will be quickly detected and remedied. Rooms will also be inspected as part of the check-out process to ensure faucets do are not left on. Additionally, a system of interconnected pipes has been designed to capture all effluent discharges and channel them into the desired discharge point. Discharges from the washrooms are channeled into pipes which run along the western side of the hotel, and then enter the septic tank (figure 7). The septic tank has an approximate capacity of 31.7 cubic meters and is situated to the south of the hotel.

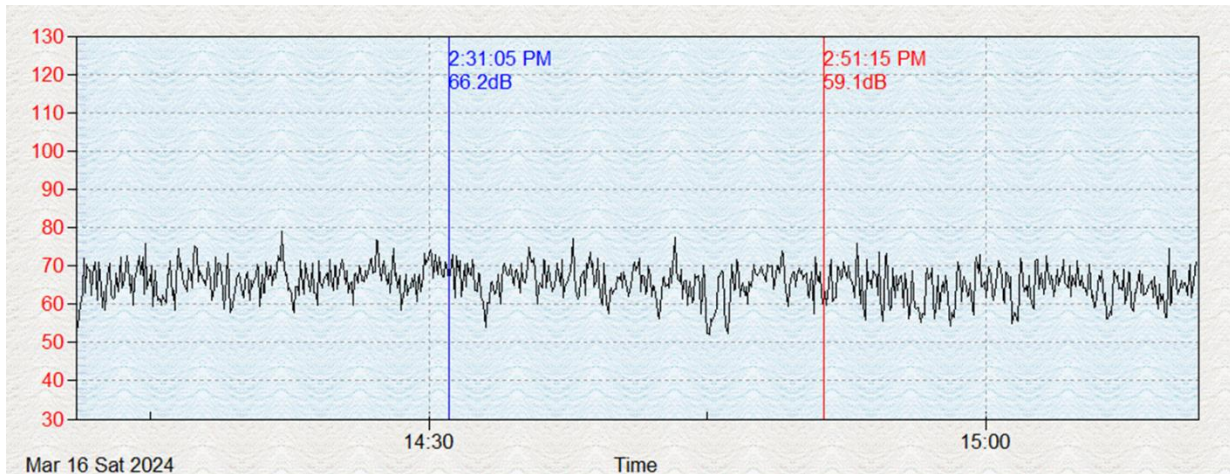
Figure 8: Graphical Representation of Noise Assessment Results

The hotel is situated in a mixed-use zone (commercial and residential), south of a busy public road. A noise assessment was conducted for approximately one hour which recorded an average sound level of 65.6 dB. This level was lower than the daytime residential and commercial limits as outlined in table 1 above. The maximum and minimum noise level measured 79dB and 51.9 dB respectively. The maximum noise level exceeded the daytime noise limits for a residential area but was still lower than the daytime commercial limits. The exceedance in the daytime residential limit was attributed to loud music emanating from the vehicle of a customer who stopped to conduct business at the supermarket. The figure below graphically depicts the results of the noise assessment.

The hotel's operation will therefore not result in sound levels above what is experienced by residents and other stakeholders in the vicinity of the hotel.

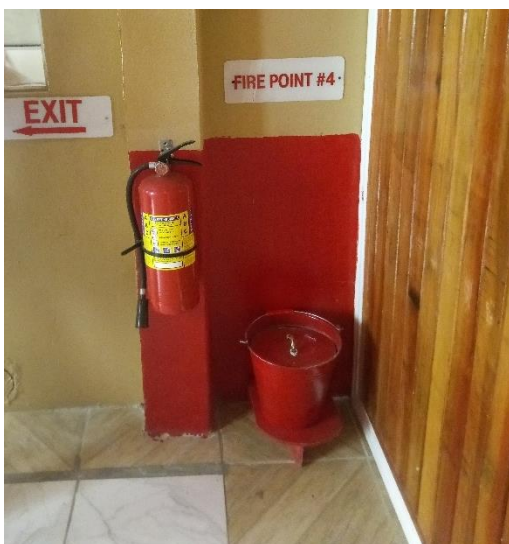
Figure 9: Fire extinguisher and sand bucket at one fire point

Each room has a smoke detector system installed. However, fire extinguishers are placed strategically. The hotel is equipped with 6 fire extinguishers placed at marked locations throughout the hotel. The extinguishers will be serviced annually, to ensure they are operable, and can be used in event of a fire emergency. In addition, sand buckets are available at some fire points (figure 9).

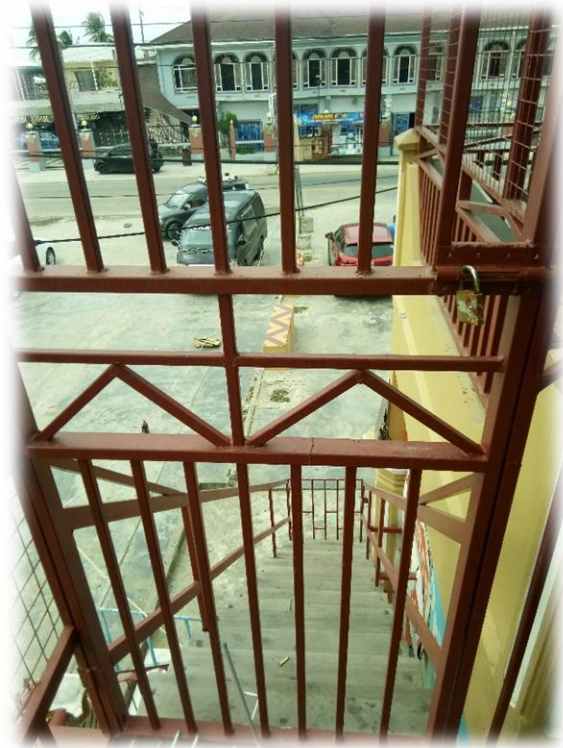
Figure 10: Northwestern fire escape

There are 2 fire escapes, one to the south and another to the northwestern section of the hotel (figure 10). Several exit signs are present throughout the hotel, so that guests can easily find the fire escape and evacuate the hotel in the event of an emergency.
